The Takanodai landslide, Kumamoto, Japan: insights from post-earthquake field observations, laboratory tests and numerical analyses

G.Chiaro¹, M. Umar², T. Kiyota², C. Massey³, K. Chew¹ and J.S. Kim¹

1) University of Canterbury, New Zealand; 2) University of Tokyo, Japan; 3) GNS, New Zealand

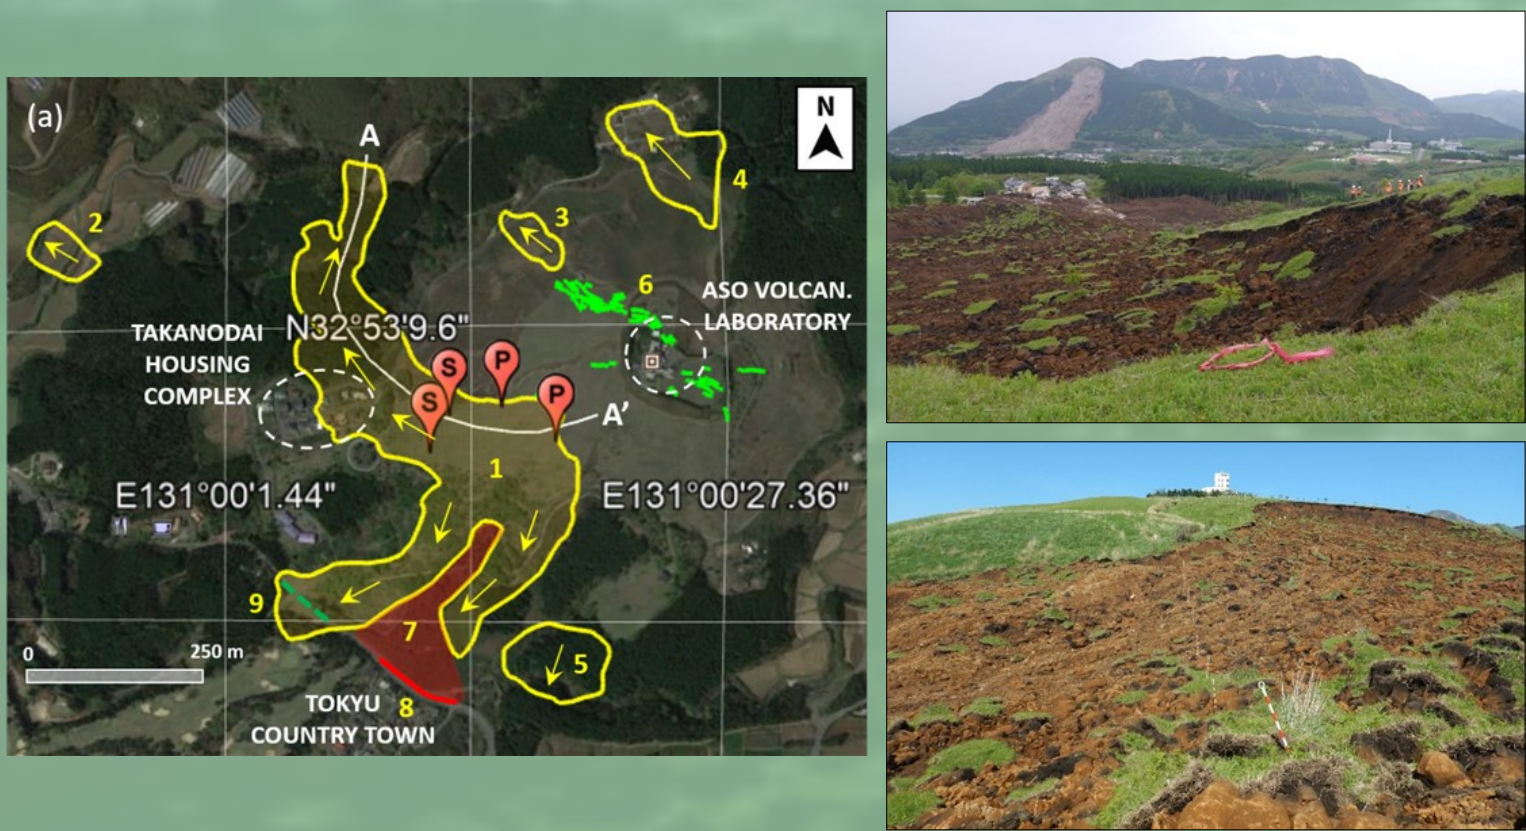
On 14-16 April 2016, a series of earthquakes of Mw 6.2-7.0 struck the Island of Kyushu, Japan. Among many landslides, the earthquakes caused the failure of a gentle slope near the Aso Volcanological Laboratory in Minamiaso Village. This large-scale runout slope failure, known as the Takanodai landslide (Figure 1) destroyed at least 7 houses and killed 5 people, threatened many other houses and blocked several roads.

Figure 1. Takanodai landslide (Chiaro et al., 2017)

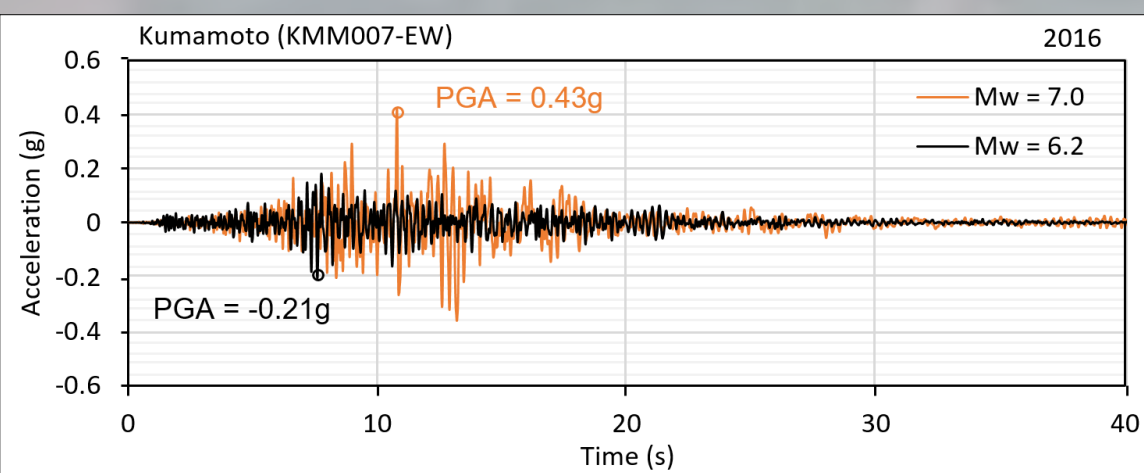
Earthquake records obtained from KMM007 Station were applied at the base of the slope model for this analysis. The earthquakes considered were the 14 April (M_w 6.2) and 16 April (M_w 7.0) events.

Figure 2. 2016 Kumamoto earthquake ground motions

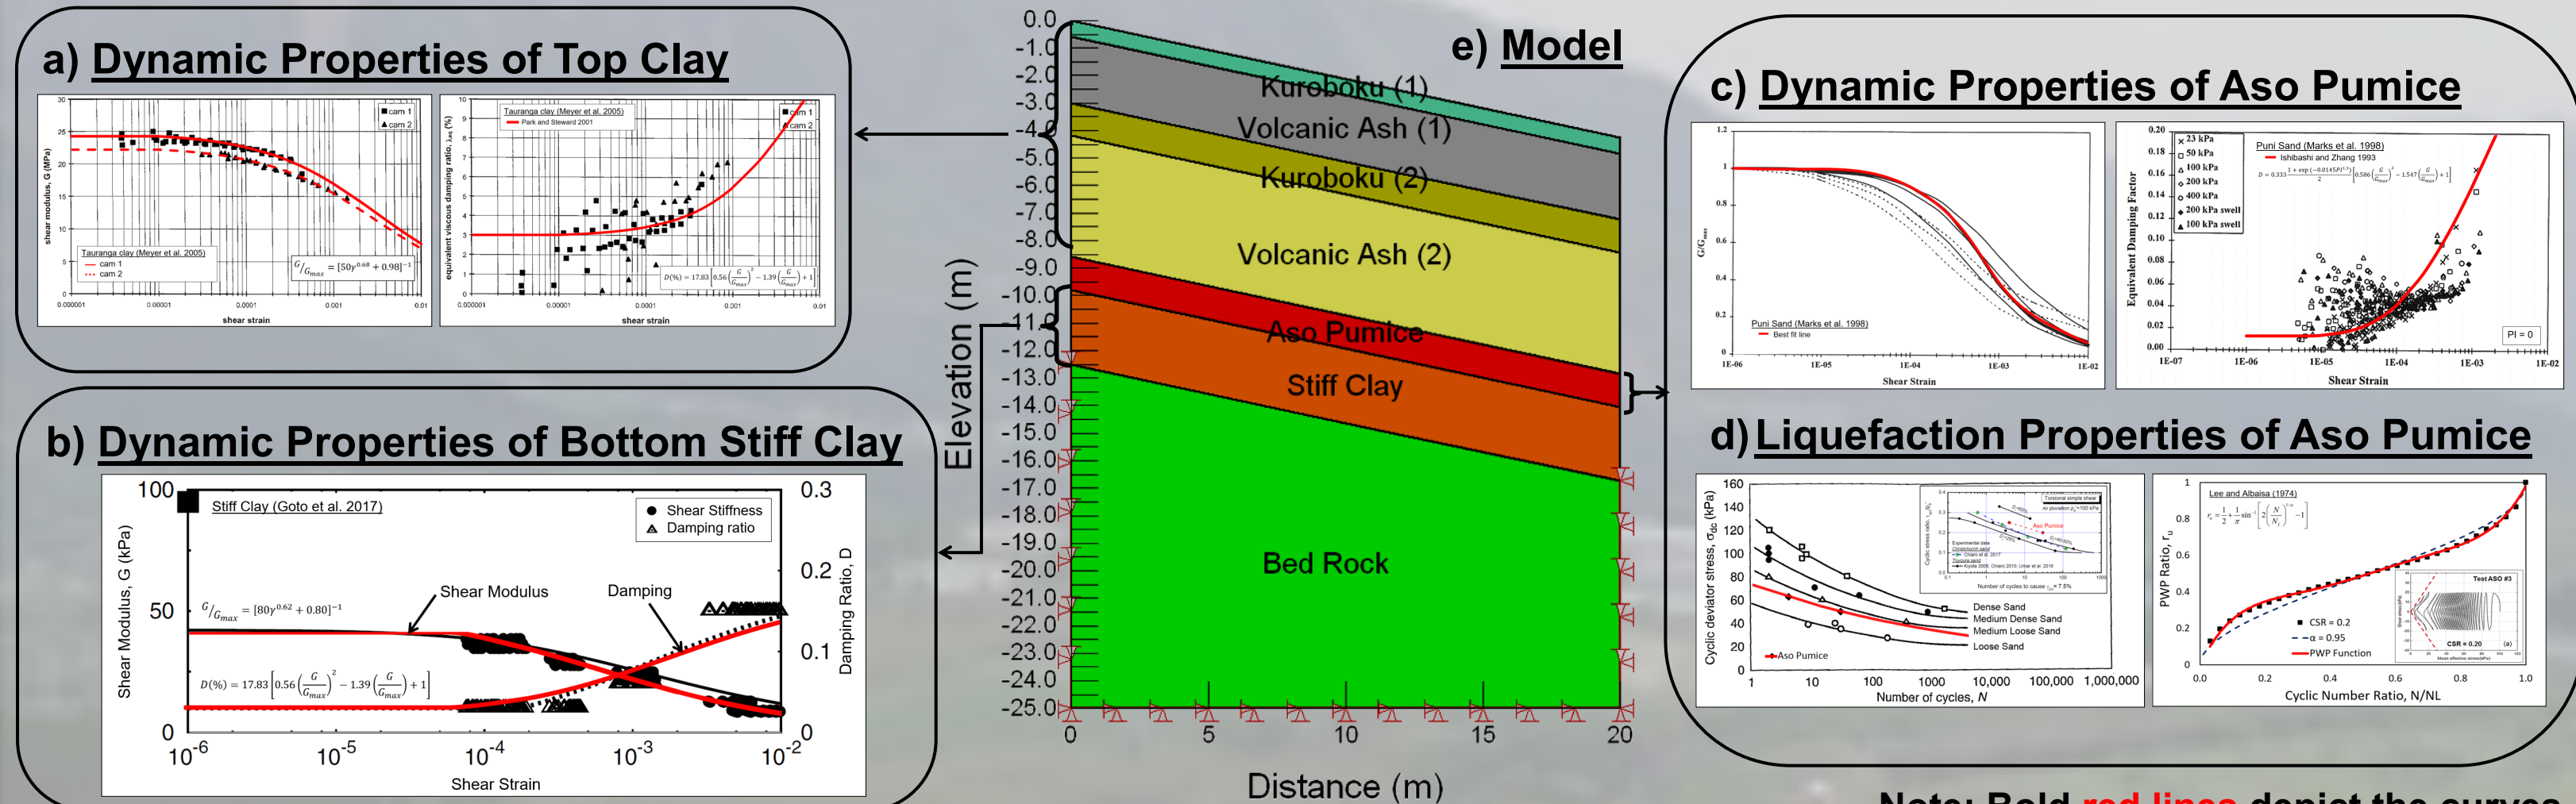
In Quake/w, strain-dependant shear modulus and damping values were required for each soil element in order to conduct a dynamic analysis using the equivalent linear method. These properties are summarised in Figure 3. The sand-like behaviour of Aso pumice resulted in susceptibility to liquefaction when subjected to earthquake shaking. Liquefaction characteristics and generation of excess pore water pressures in the pumice were modelled using pore water pressure and cyclic number functions derived from Umar et al. (2017).

Figure 3. Soil profile and its associated dynamic characteristics

Step 1: A slope segment was created as seen in Figure 3(e) to verify the model accuracy and check the sensitivity of soil parameters (Table 1) and the pumice layer thickness. Preliminary results indicated the onset of liquefaction in the pumice layers in addition to significant deformation under intense shaking could be the cause of the slope failure. Analyses were then carried out on the entire slope profile.

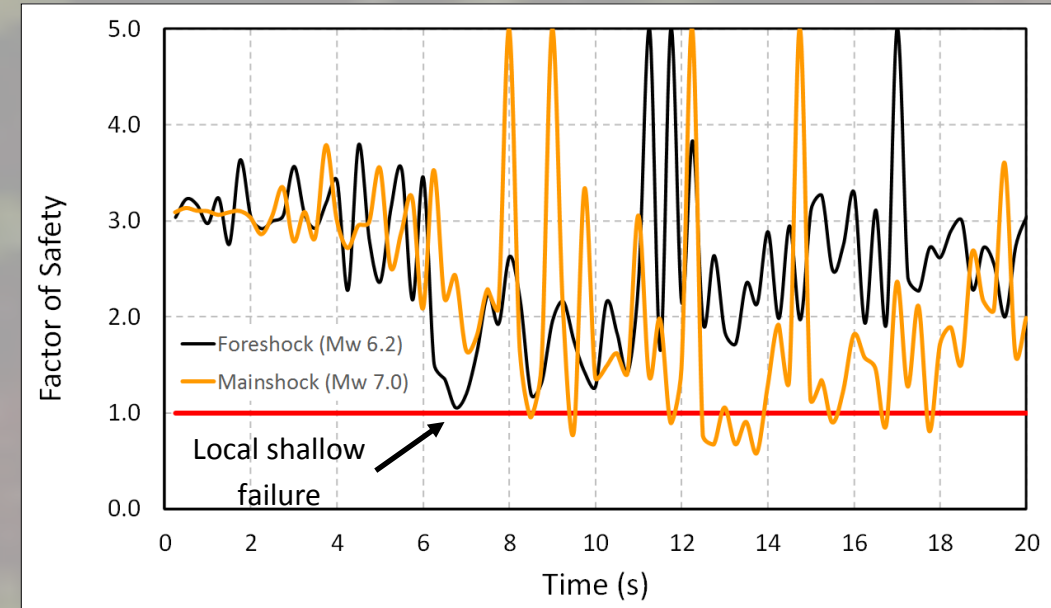
Step 2: The foreshock ground motion recorded at the KMM007 station was used in the analysis. It was observed that the Takanodai slope failure was not activated, matching eye-witness accounts of a non-failure before the mainshock. The dynamic factor of safety was FS>1 (Figure 4).

Step 3: The mainshock ground motion recorded at the KMM007 station was used. During this event, slope failure was predicted as the FS against slope failure dropped to 0.794 (Figure 4).

Figure 4. Dynamic factor of safety during the Kumamoto earthquake

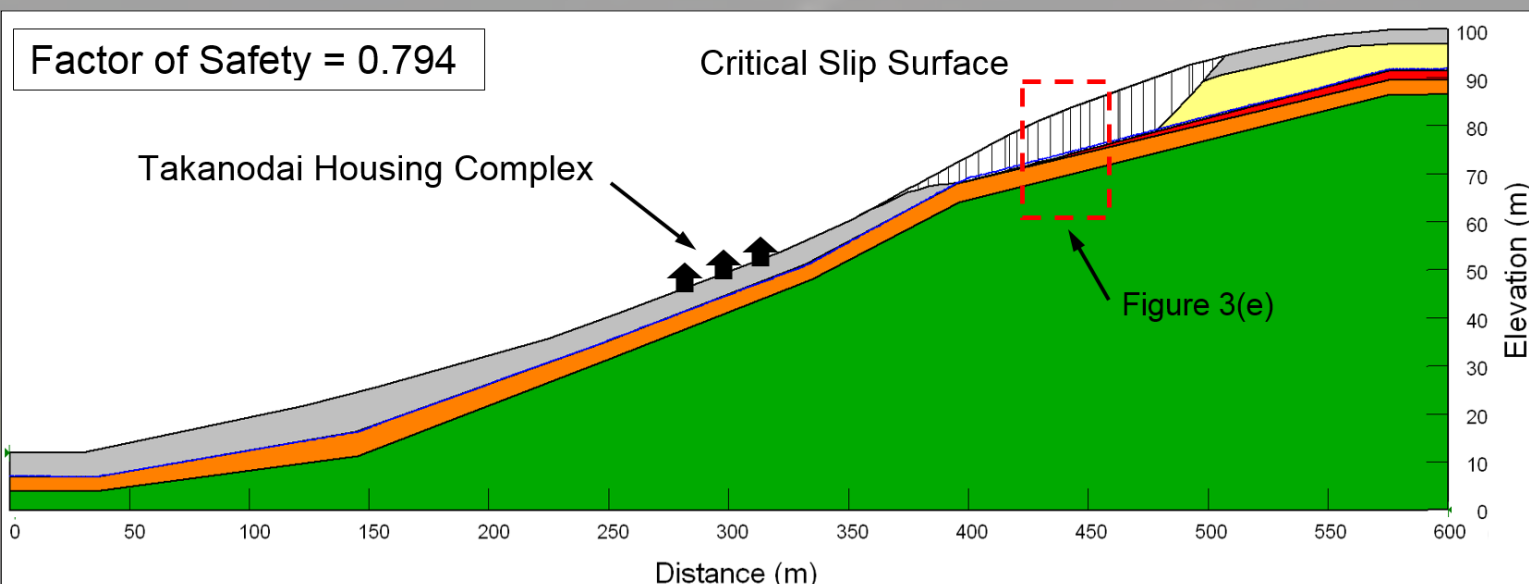
Moreover, the failure surface displayed from the Slope/w analysis (Figure 5) was found to be in agreement with that observed at the site (Figure 6).

Figure 5. Slope/w model showing critical slip surface

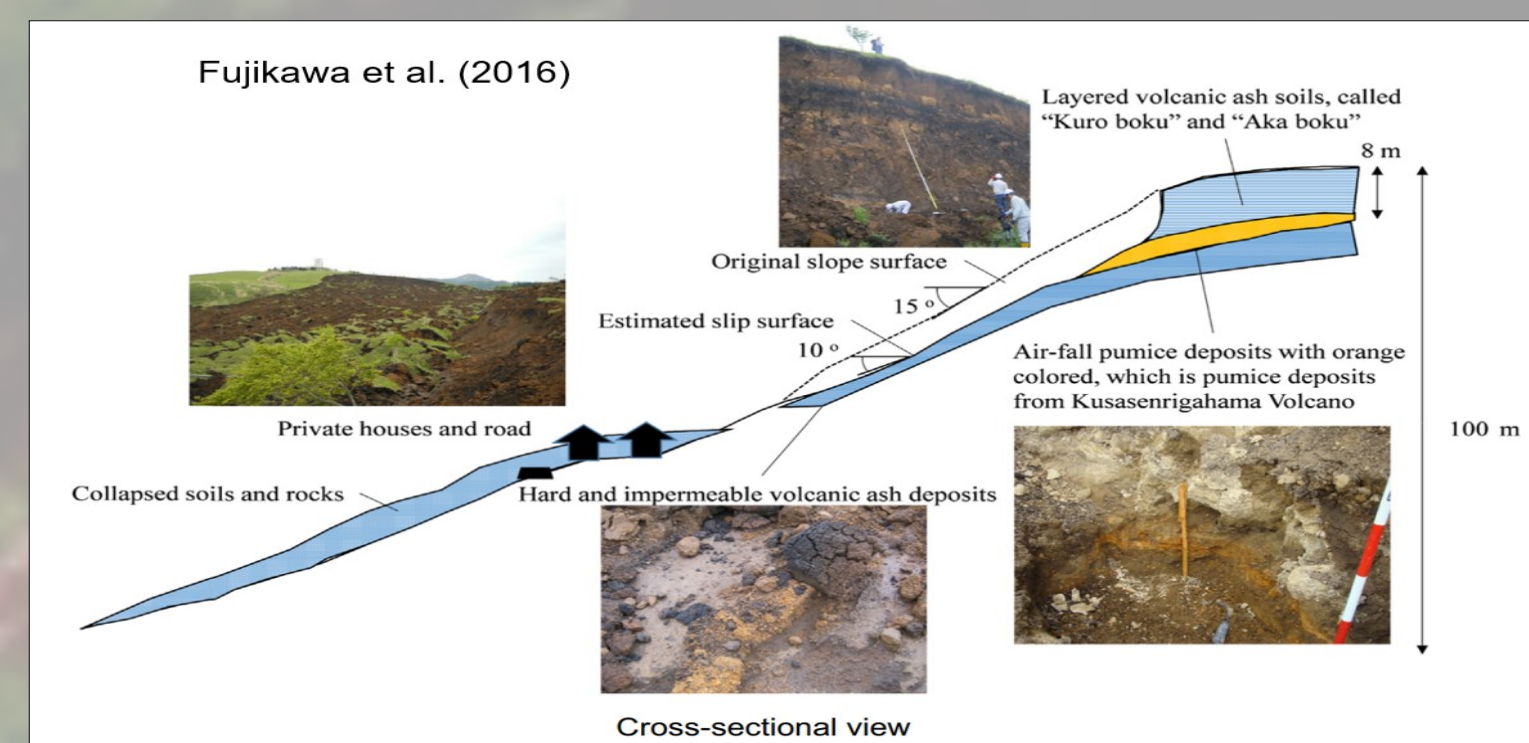
Figure 6. Landslide failure mechanism identified at the site (Mukunoki et al., 2016)
